# Dictation Products Service Bulletin

**Model:** BI-85, BM-77, BM-88

**No.** 27

**Subject:** Original FWD Motor No Longer Available

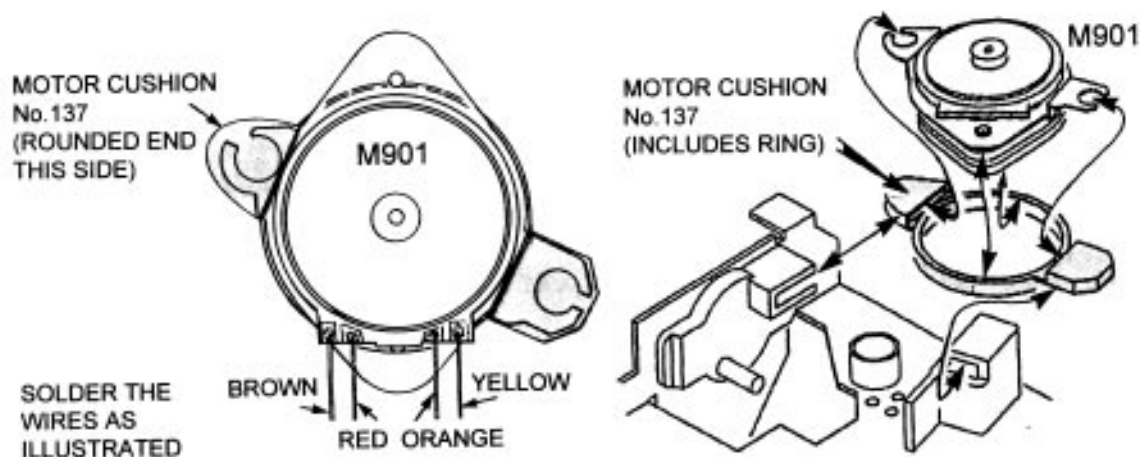
**Motor Assembly Installation**

The original FWD Motor is no longer available.

- Remove the original wiring from the original motor. Remove the original motor from the mechanical chassis.
- Remove the motor cushion No. 137.
- Install the cushion No. 137 on new motor and reverse the procedure.
