Dictation Products Service Bulletin

Model: CCP-200 RF/D

No. 4

Subject: No Audio

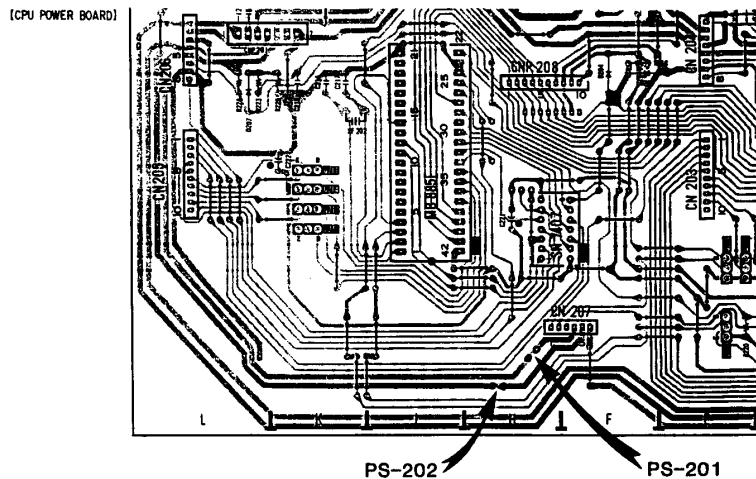
No audio on any of the channels.

Note: These fuses are not listed in CCP-200 Service Manual.

Replace blown fuses on +15V and -15V power supply lines to the Audio Board.
The fuses are located at the H1 section of the CPU Power Board as PS-201 (+15V) and PS-202 (-15V).
