Service Information

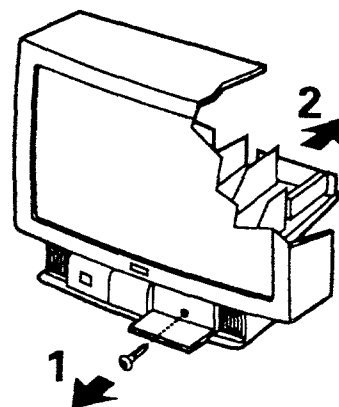
Fig. 1

During production, as from week 9147, the control panel has been fixed with a screw from the front side of the cabinet (see Fig.1). This means that this screw must first be removed before the chassis can be pulled back and set in the service position.
