# SONY TUNER REPAIR

SUBJECT: COMMON FAILURE OF SONY TUNER # 1-465-371-11/ -12

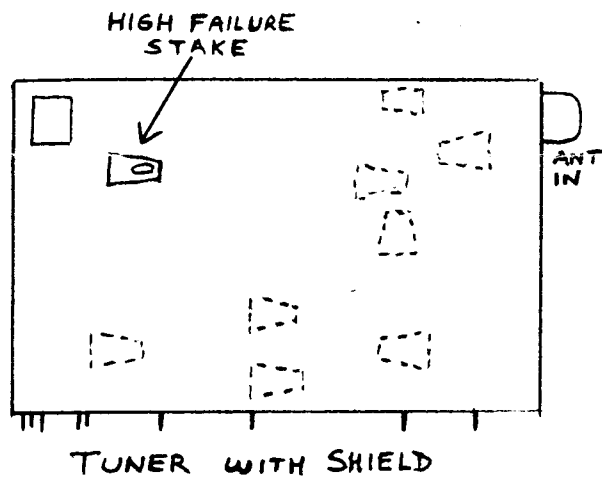
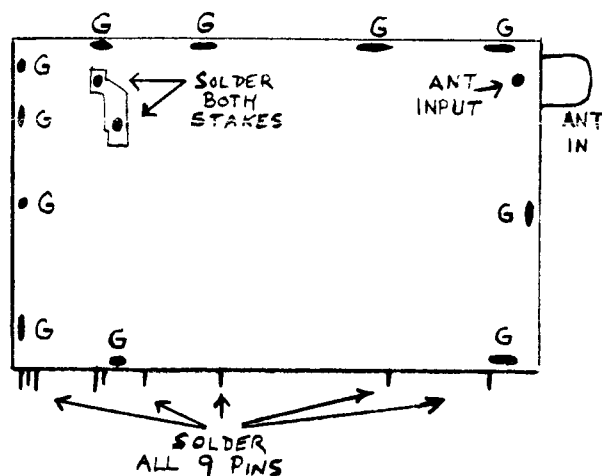
SYMPTOM: No/ intermittent stations.

CURE: The main cause for the high failure rate on these tuners is poor connections at the ground stakes on the circuit board. One stake in particular seems to be the culprit. Refer to the diagram below for the location.

Remove the tuner from the set. Remove the shield off the printed circuit side of the tuner. Take notice of the 9 tabs and the square hole on this shield. These tabs make contact with the ground stakes on the circuit board when it is snapped in place. The stake that causes the problems is the one under the tab nearest the square hole on the shield!!

Using a low wattage pencil iron, solder this stake and also the one just above it on the same trace. Now before you throw the shield back on & "write it up", it is good practice to touch up some other possible "trouble" spots. First resolder all 9 pins of the tuner. next solder the antenna input pin. Now resolder the "grounds" along the outer edge of this board. Caution: Be very careful not to use excessive solder or heat to avoid bridging or damaging components!

This completes the repair. Check over your work, replace the shield, install the tuner and check performance.
