VCR / CAMERA SERVICE BULLETIN NO:71

DATE: NOV 1993

MODELS: M458, M468, M63, M657,
M658, M659, M668,
M758, M759, M769

SUBJECT: Intermittent Audio Recording

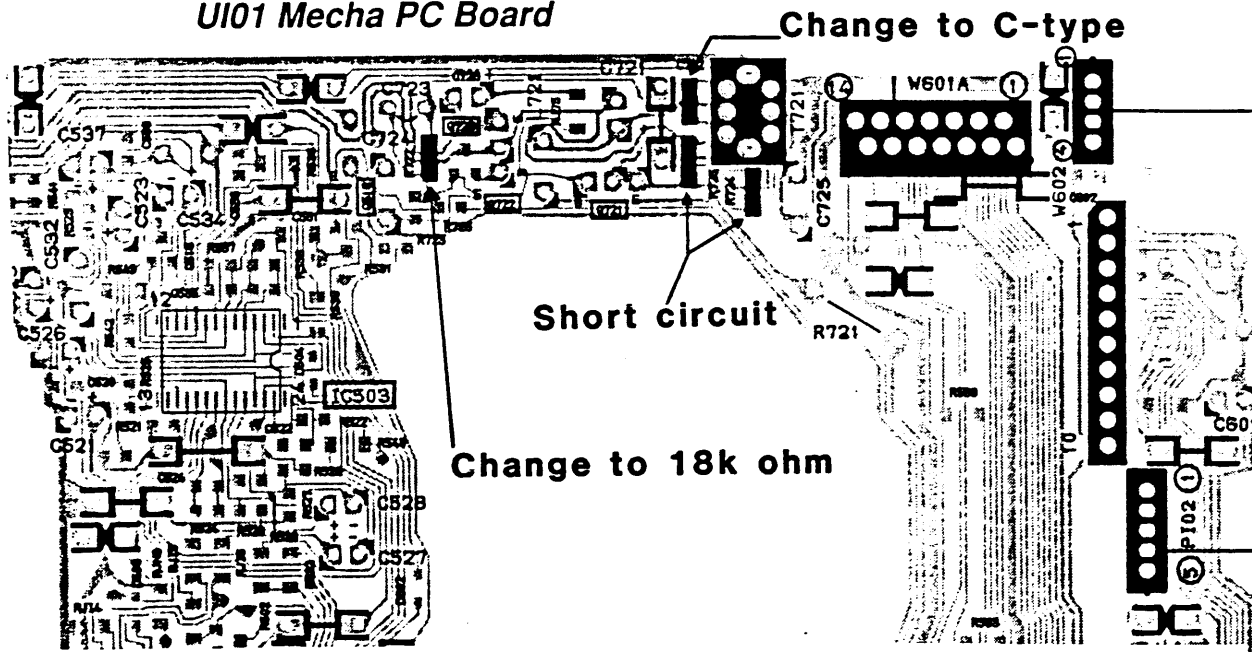
UI01 Mecha PC Board

Symptom: Intermittent Audio Recording

- Action:
1. Change R722 to the new value listed in the table below.
 2. Replace R724 and R725 with a jumper.
 3. Replace Capacitor C722 with the new C-type capacitor listed in the table below.
