TOSHIBA AMERICA CONSUMER PRODUCTS, INC.

## TECHNICAL BULLETIN

No. VCR9608

**Subject:** Defective LD71A and LD72A in units with the S601 cold solder joint. Refer **Ref.#** VC9602 to Technical Bulletin VCR9607.

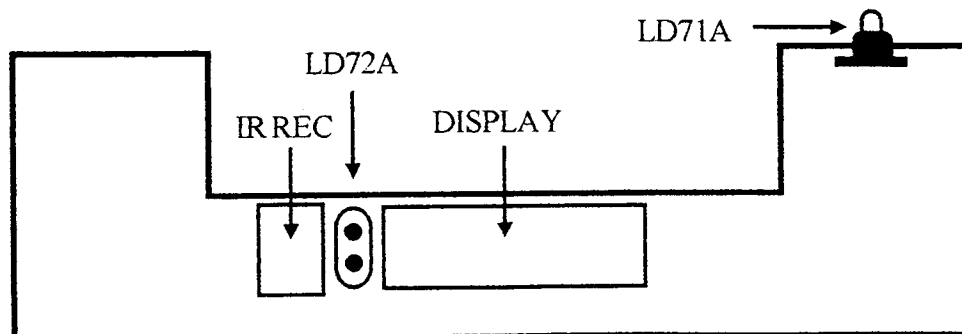
FUNCTION/TIMER PC BOARD COMPONENT SIDE

**Symptom:** Same as the S601 - the VCR turns off a few seconds after it is turned on. In some cases, the cassette holder assembly tries to load without a tape. However, if the VCR is left plugged in, the Cable Box Control (CBC) IR transmitters could develop enough heat to render their holders inoperative.

**Corrective Action:** Resolder the cold joint on the Start Sensor, S601, and also check the solder joints on the End Sensor, S602. Inspect the IR transmitters, and if their holders (LD71A and LD72A) are defective, replace them. Check the operation of the IR transmitters with an IR detector following the cable box setup instructions on page 31 of the owners manual. If the IR transmitters don't transmit, check the transmitters and their drive circuitry. Replace the needed components and recheck the operation of the IR transmitters. Ensure that the IR transmitters are off during normal operation.
