TOSHIBA AMERICA CONSUMER PRODUCTS, INC.

TECHNICAL BULLETIN

No. VCR9609

Subject: The trace carrying the 3.58MHz reference signal to the Color Signal Enhancement (CSE) board may be broken at pin 13 of PU01.

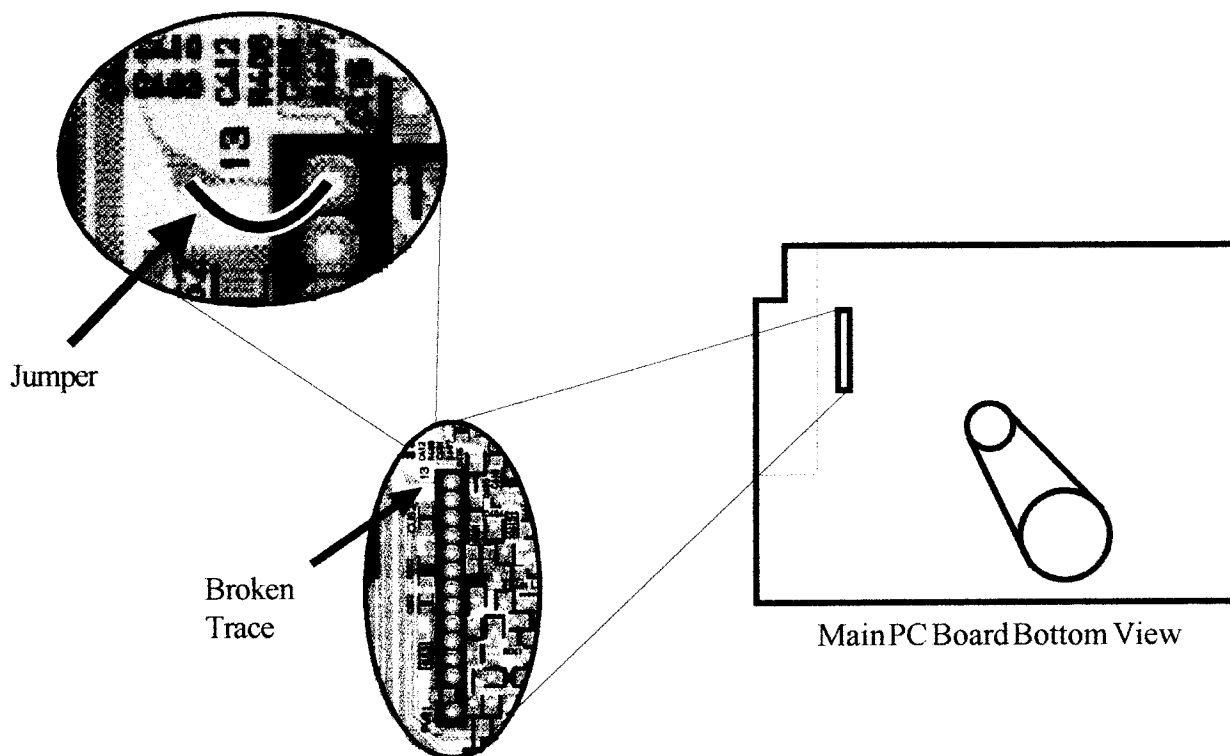
Symptom: There may be no color in playback of a known good tape. Tapes recorded on the VCR in question have color when played on a known good machine. This problem may be intermittent.

Corrective Action: Solder a jumper between pin 13 of PU01 and the solder pad approximately one quarter of an inch out on the trace. This solder pad is where the trace turns at a 45 degree angle.
