olivetti

HANTAREX

1431.
1431/HA01.
CDU-1431.
CDU-1431/HA01.

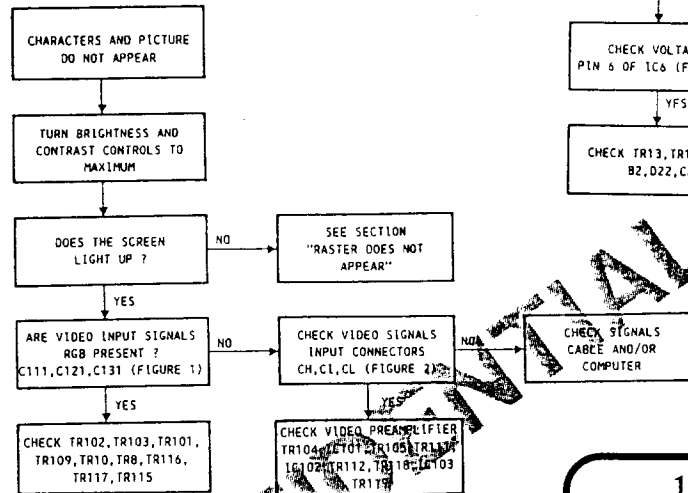
Characters and Picture Missing

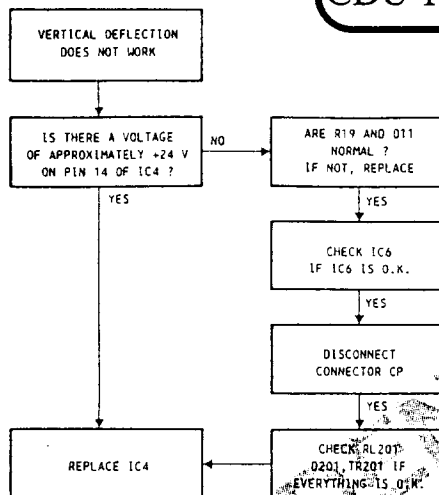
Vertical Deflection not Working

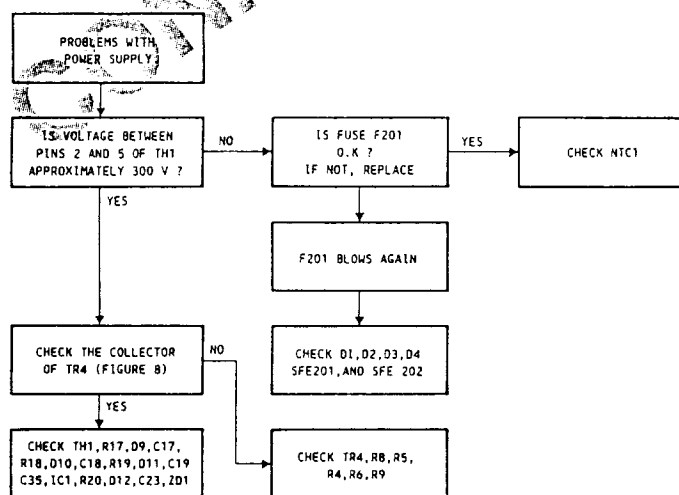
Power Supply Problems

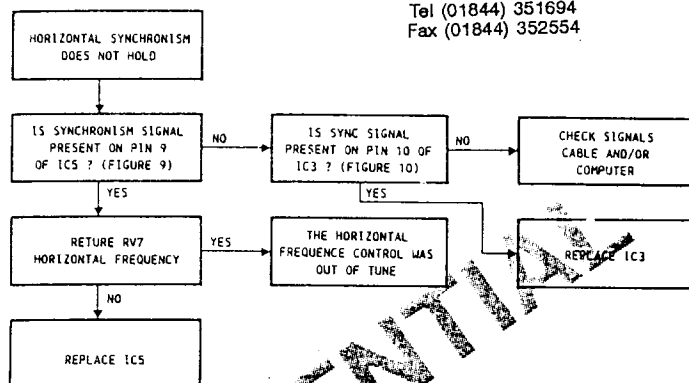
Horizontal Sync Problems

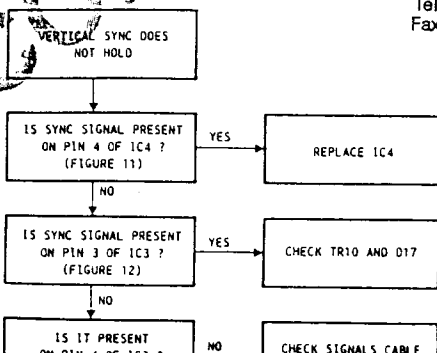
Vertical Sync Problems

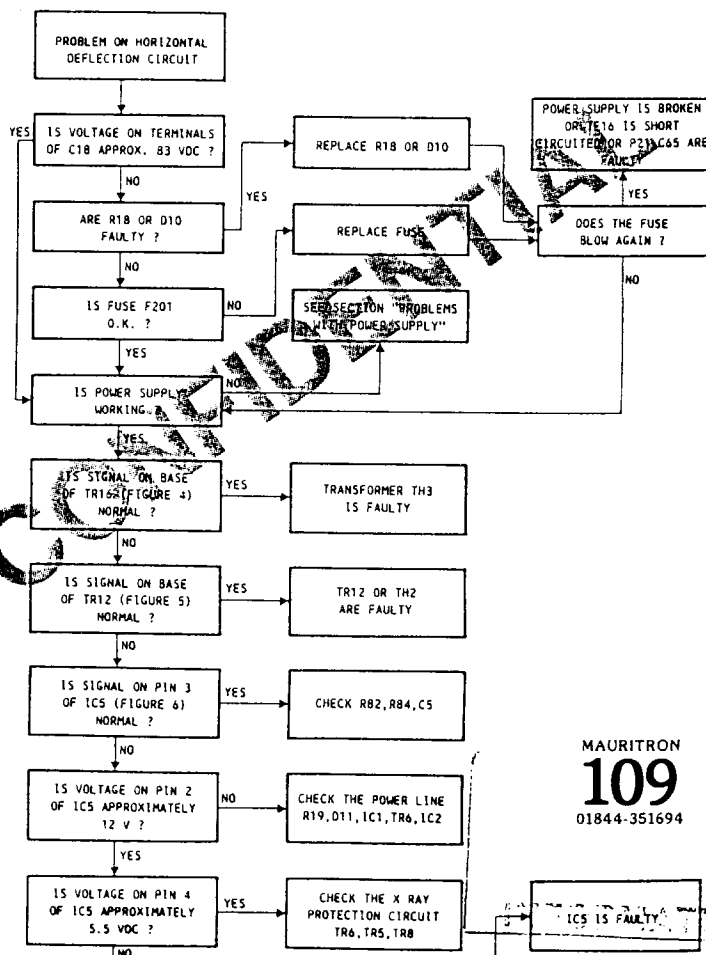
Horizontal Deflection Circuit Problems
