Video Products  
Service Bulletin

Model: SLV-353UC/555UC/757UC

No.108

Subject: RKB Cam Gear Alignment Correction Date: February 12, 1990

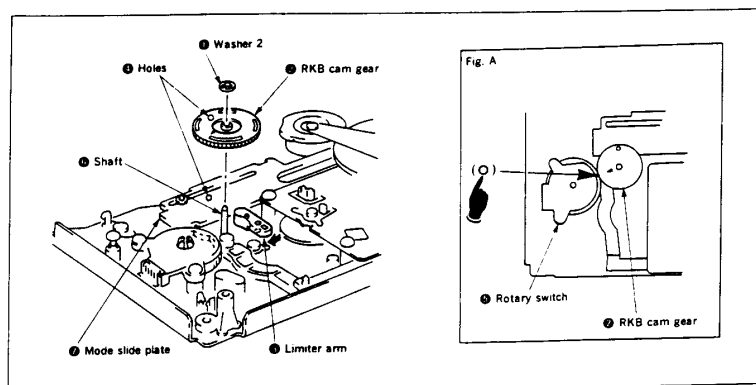
Fig. 3-31.

Solution: 3-25. RKB CAM GEAR (Fig. 3-31)

- 1) Remove the adjuster arm ass'y. (Refer to 3-22.)
  - 2) Remove washer 2 ①, then pull out the RKB cam gear ②.
- [Precautions on remounting] (EJECT MODE)
- When the limiter arm ③ is pushed in the direction of the arrow, the pin must fit into the notch on the RKB cam gear ②.
  - The ○ mark on rotary switch ④ must match up with the ◀ mark on the RKB cam gear ② as shown in Fig. A.
  - Apply 1/2 drop of lubricant to shaft ⑤.
  - Match up the holes ⑥ on the RKB cam gear ② and the mode slide plate.

Please correct paragraph 3-25 on page 19 of the VHS Adjustment Manual II to read as follows:
