Video Products  
Service Bulletin

Model: SLV-353UC/555UC/757UC

No. 131

Subject: Unit Shuts Down (Photo Sensor Kit) Date: September 28, 1990

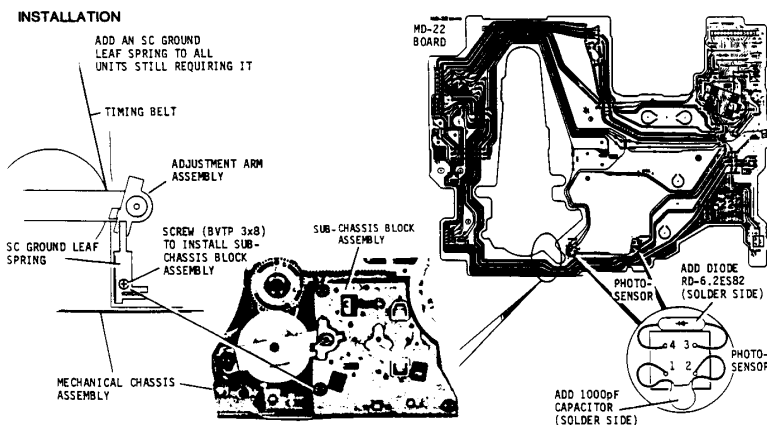
Unit shuts off during PB, REV, FF, or REW.

Qty	Description
1	SC Ground Leaf Spring
2	RD 6.2-ESB2 Diodes
2	Photo Sensors - PS6002
2	1000pF Ceramic Capacitors

Solution: A Photo Sensor Kit should be installed whenever any of the above symptoms occur.
