**1995****TOSHIBA** *Consumer Products***Date:** MAR 95**TECHNICAL BULLETIN****No.** VCR9501**Product:** VCR**Models:** M-650, 650C, 660, 660C, 750, 750C, 750J, 760, 760C, 760J, 770**Subject:** Power supply switching interference.**Ref. #:** 10A-9402**Symptom:** TV picks up power supply switching interference from VCR.**Required part(s):**

## POWER SUPPLY CIRCUIT DIAGRAM

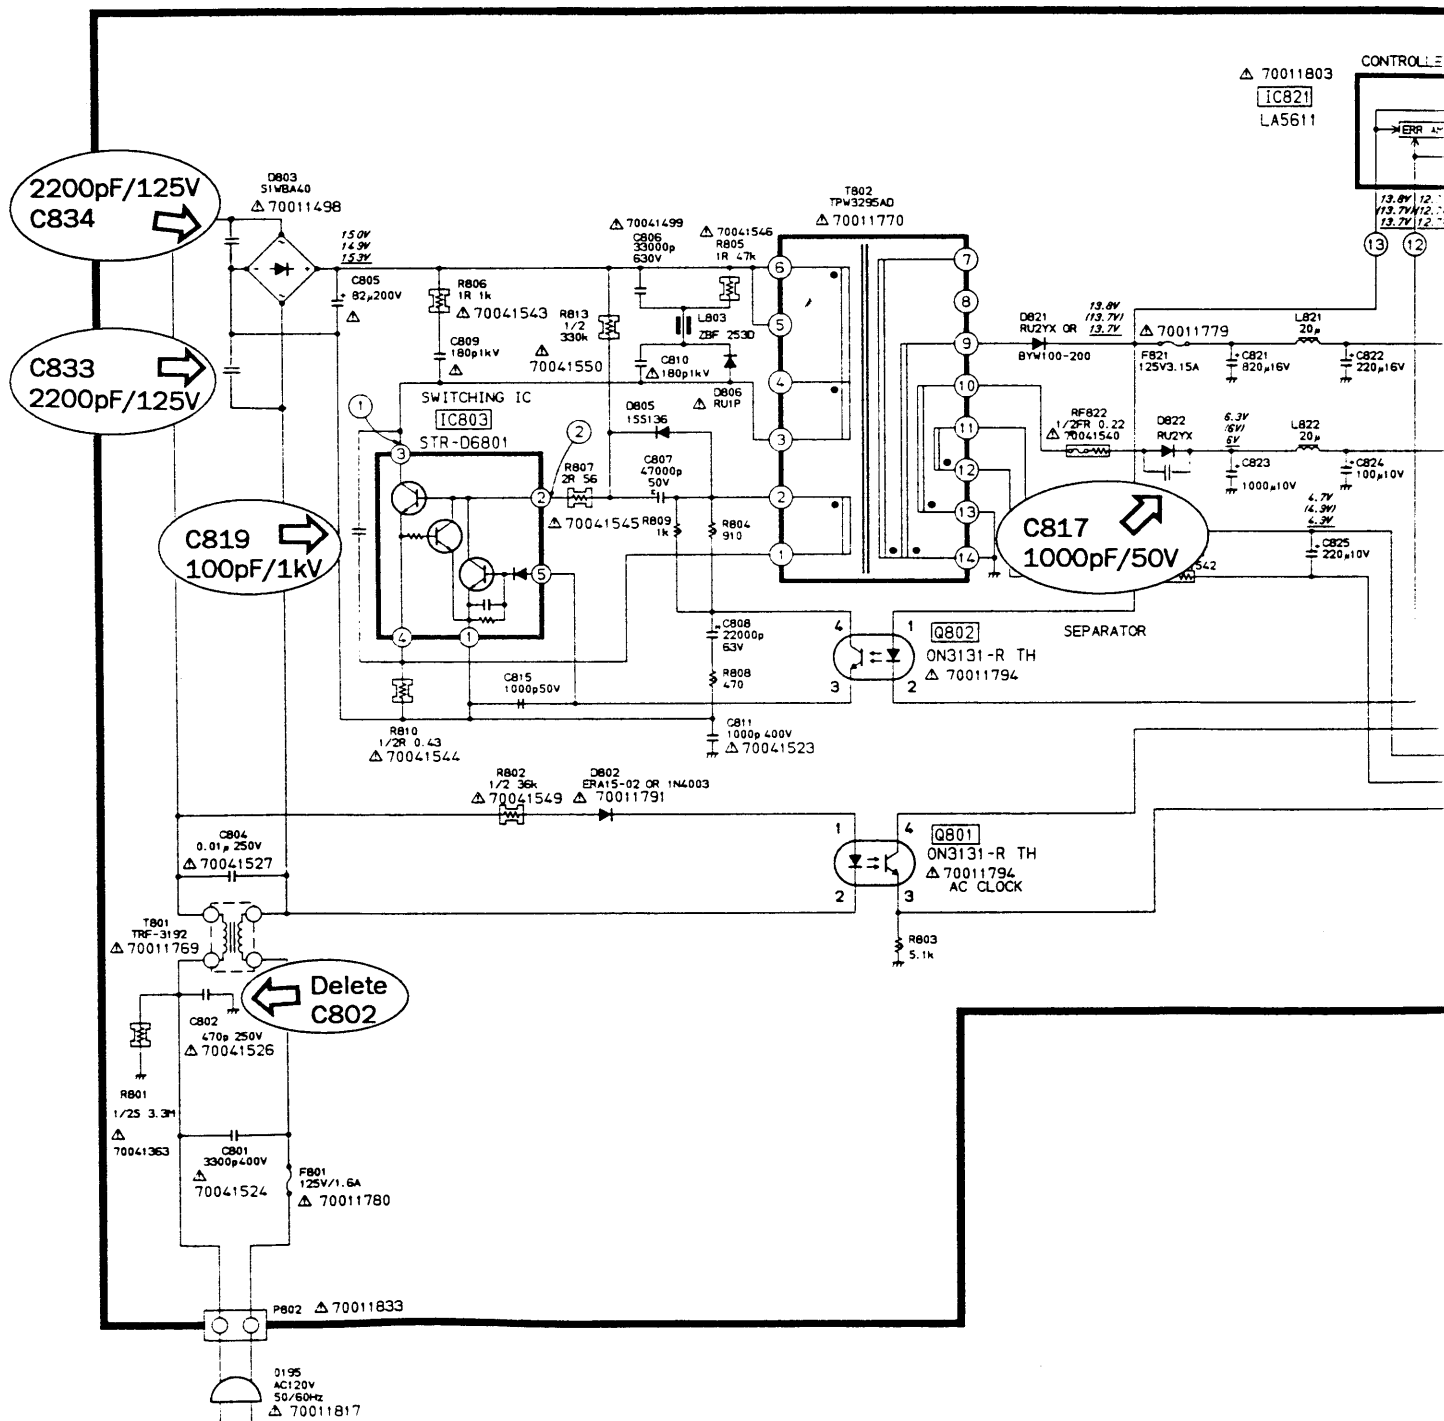
C802 Delete

C834 2200pF/125V

C819 100pF/1kV

C817 1000pF/50V

C833 2200pF/125V

**Corrective Action:** 1) Remove capacitor C802.

2) Add 4 Capacitors, from 70903925 capacitor kit above, to the foil side of Main PC board, as shown in the illustrations on the attached sheet.
