TOSHIBA AMERICA CONSUMER PRODUCTS, INC.

TECHNICAL BULLETIN

No. VCR9601

Subject: Video tape removal

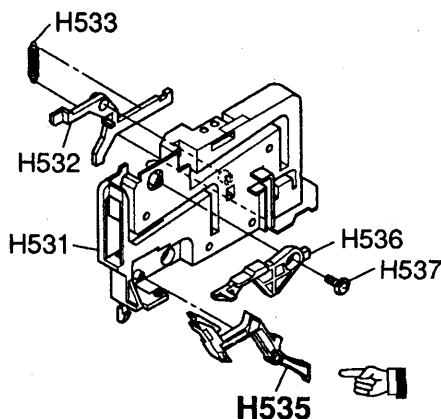
Symptom: The VCR will not eject the video tape.

H535	70790539	Lever - Door Opener
------	----------	---------------------

Corrective Action: Replace the door opener lever (H535) located on the left side of the cassette loading mechanism. Refer to the figure below for the location and position of the lever.
