# VINTAGE RADIO

## Astor 1952 Hybrid GP/PS Portable Radio

Astor's hybrid portable is a combination of the model GP's case with the later model PS circuit. It incorporates an RF preamplifier stage for excellent sensitivity, which is crucial for a portable radio. It's also notable for its 8-inch loudspeaker; quite large for a portable.

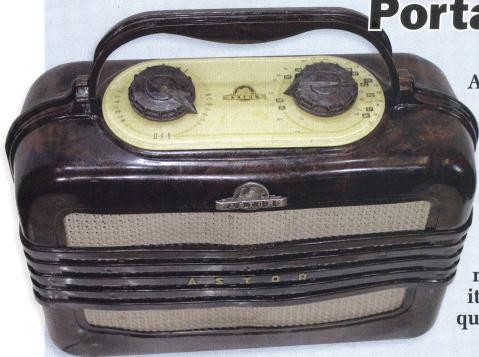
Incidentally, this case is not Bakelite but is thermoplastic (thermosoftening plastic). Because of this, heat generated from the internal components has caused quite apparent distortion.

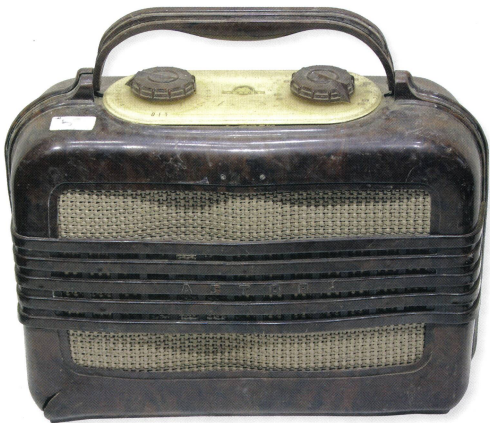
Before restoration the cabinet was in an unkempt state with a tear in the plastic at the lower left-hand corner.

The cabinet was quite grubby and had a tear in the plastic at the lower left corner. This was patched with Araldite and a missing Astor swan badge was replaced from my spares bin.

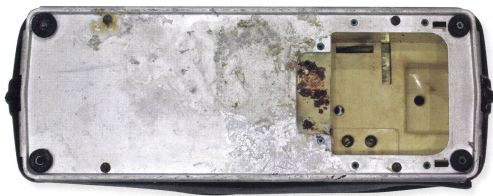
These two views of the underside of the show the battery compartment and the chassis base-plate together with the recessed 2-pin socket for the 240VAC mains input. The cover for the socket is missing.

The aluminium base-plate had been corroded by batteries left in the radio probably decades ago. After a thorough clean the plate was painted with acrylic silver paint to make it presentable. Little of that plate is normally seen anyway.
