Model: KP-57XBR10W, KP-65XBR10W**No.** 512**Subject:** Intermittent retrace lines in picture**Date:** December 6, 2000**Symptom:**
(5344)

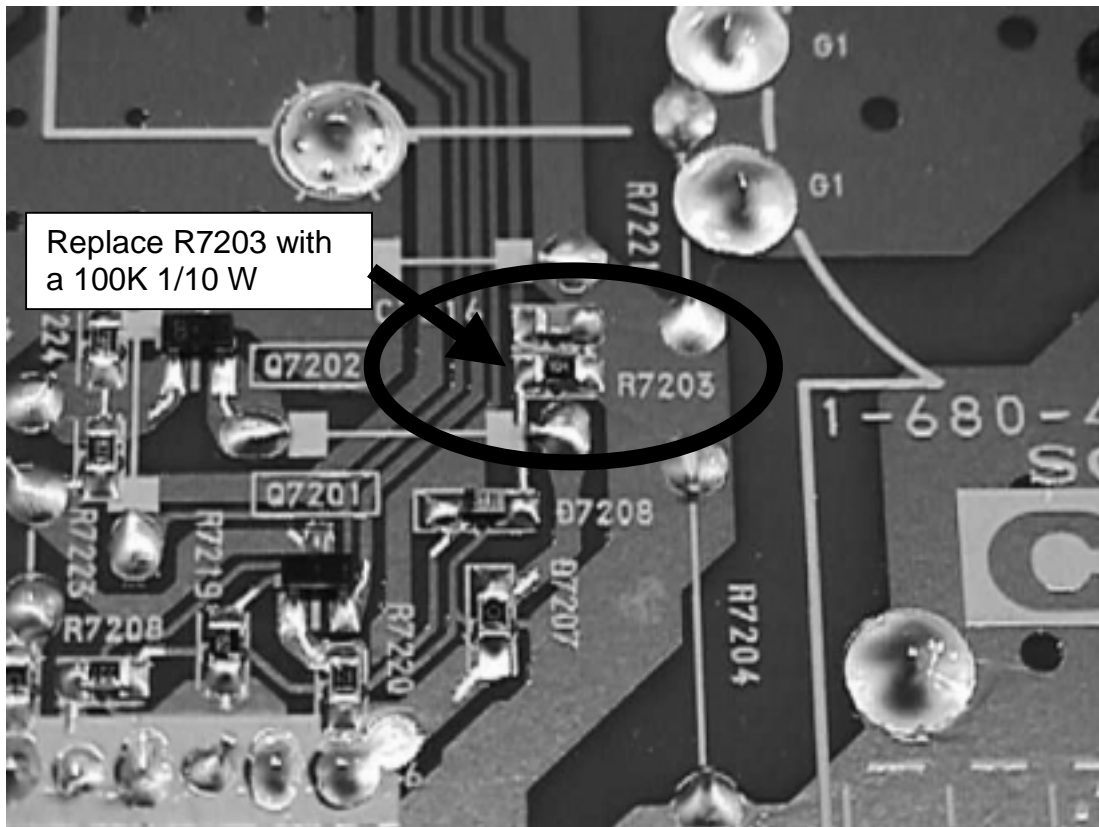
Retrace lines may appear when the set is first turned on from a cold start for about one second.

If the customer should complain of this symptom please perform the following circuit change on the CG Board.

Replace the resistor in the table below with the new resistor value on the CG Board.

Change GCUT to 10 in the Service mode.

Readjust the following items: G-2 adjustment, White balance, and Sub-bright all in the "Standard" picture mode.

Ref.	Description	Part Number
R7203	Chip res. 100K 1/10 Watt	1-216-097-00
