Model: KV-32S42, KV-32S66, KV-32V42
KV-35S42, KV-35S66, KV-35V42

No. 530

Subject: Schematic diagram incorrect, audio section

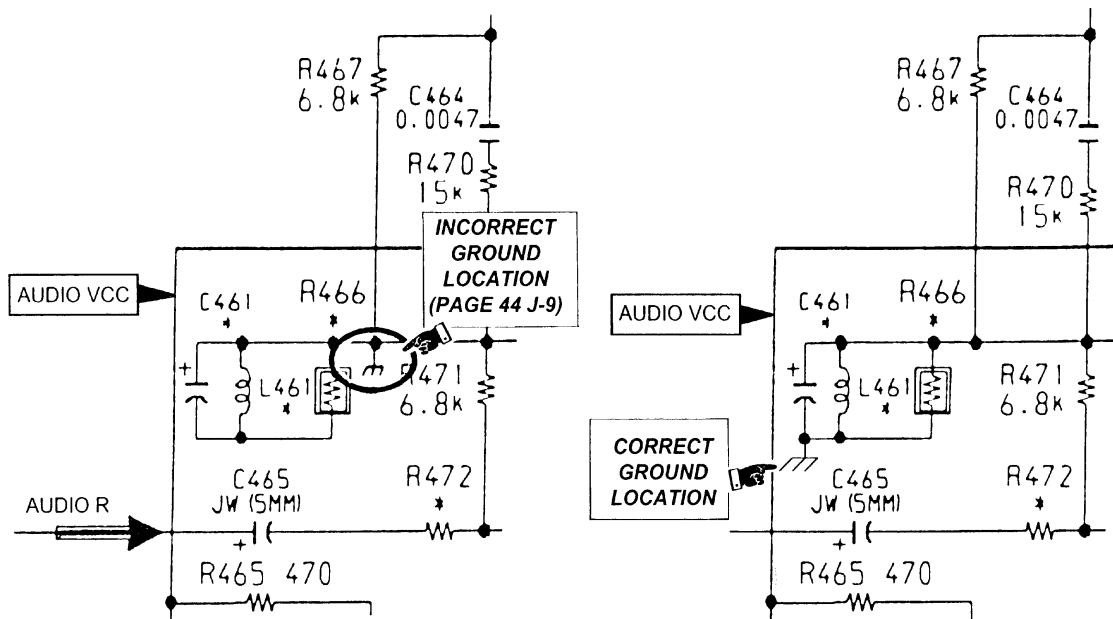
The schematic diagram of the audio circuit is incorrect.

Solution: Please correct your service manual with the information below.
