TOSHIBA AMERICA CONSUMER PRODUCTS, INC.

# TECHNICAL BULLETIN

No.VCR9604

**Subject:** Part enhancement.

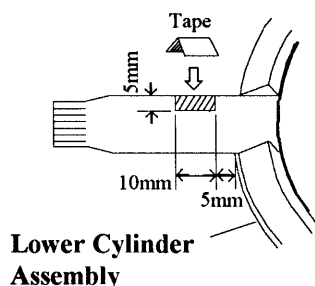
FIG. 1

**Symptom:** No picture due to possible wear on FPC wire etching.

**Corrective Action:** Place cotton, vinyl, or acetate tape on the FPC (Flexible Printed Circuit) wire of the rotary transformer, as shown in fig. 1, to prevent shorting between the FPC and cylinder holding plate.

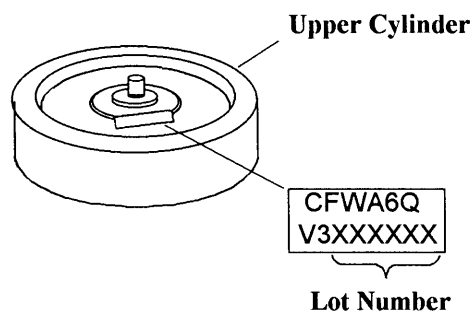
FIG. 2

**Note:** This countermeasure should only be used if you encounter the above mentioned symptom and is applicable to the following lot numbers only: 941209 - 950113. The lot number is marked on the top of the cylinder head. (see fig. 2)
