TOSHIBA AMERICA CONSUMER PRODUCTS, INC.

## TECHNICAL BULLETIN

No. VCR9607

**Subject:** Cold solder joint on Start Sensor, S601.

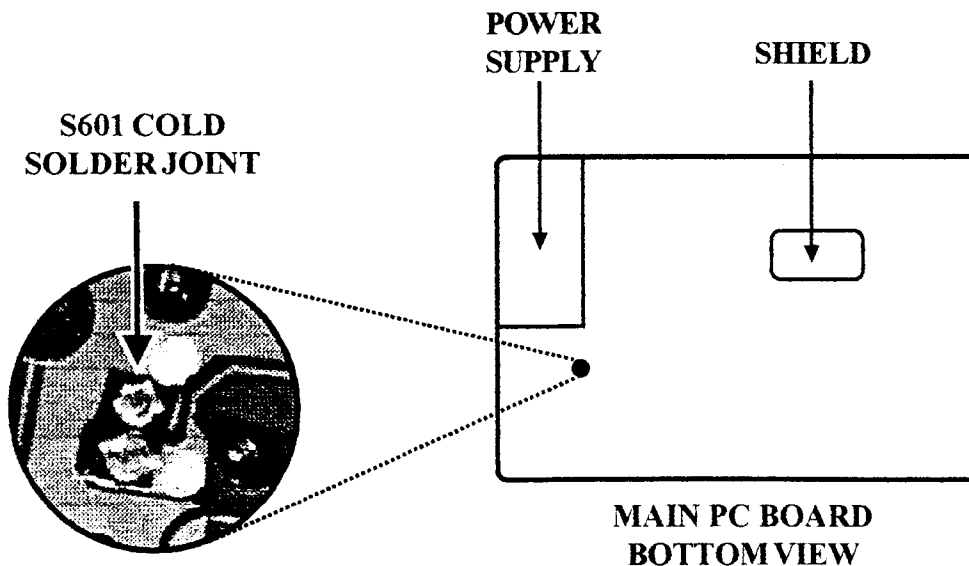
**Symptom:** The VCR turns off a few seconds after it is turned on. In some cases, the cassette holder assembly tries to load without a tape.

**Corrective Action:** Resolder the cold joint on the Start Sensor, S601, on the main PC board. Also check the solder joints on the End Sensor, S602. Thoroughly check the operation of the unit before it is returned.
